ASOS MODIFICATION NOTE 47 (for Electronics Technicians)

Revision Date: 06/03/1999

SUBJECT : Acquisition Control Unit (ACU) Memory Firmware Version 2.60
Data Collection Package (DCP) Boot Erasable Programmable
Read Only Memory (EPROM) Version 1.90

PURPOSE : Firmware upgrade for the Automated Surface Observing System
(ASOS) Operational Load.

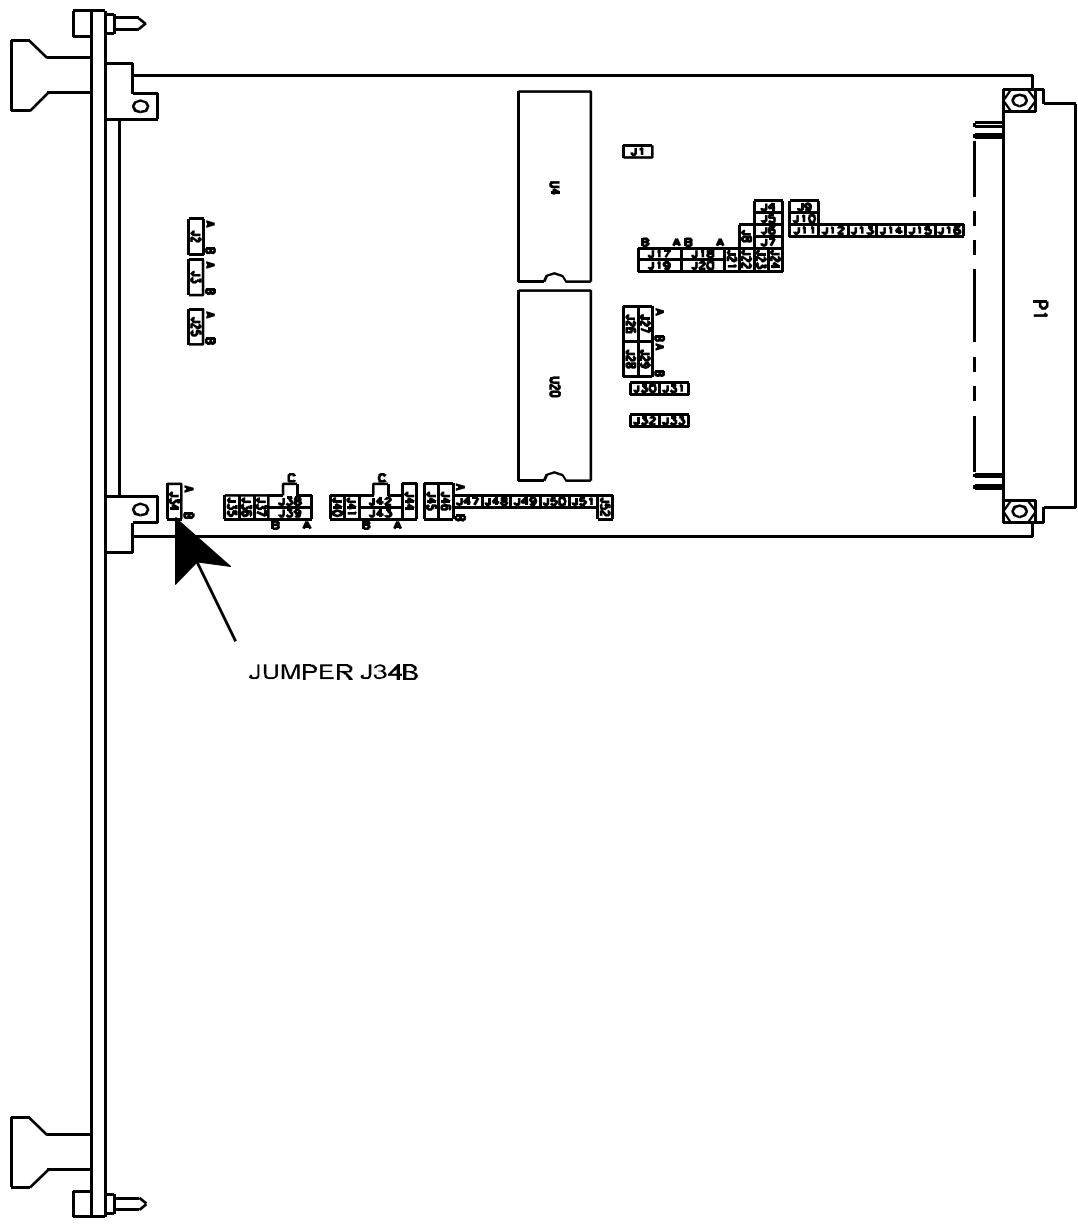
FIGURE 1

DCP MEMORY BOARD JUMPER LOCATION
(ALL COMPONENTS NOT SHOWN)

6. Disconnect the J34B connector. This will remove battery power from the memory board which is necessary to 'cold boot' the system. Set the memory board and jumper aside in a location safe from physical or ESD damage. (Refer to figure 1 for jumper location.)

Jumper J34B is installed after EPROM replacement on the CPU boards. This jumper should be removed for a minimum of 5 minutes which will ensure adequate time for the memory circuits to properly discharge.

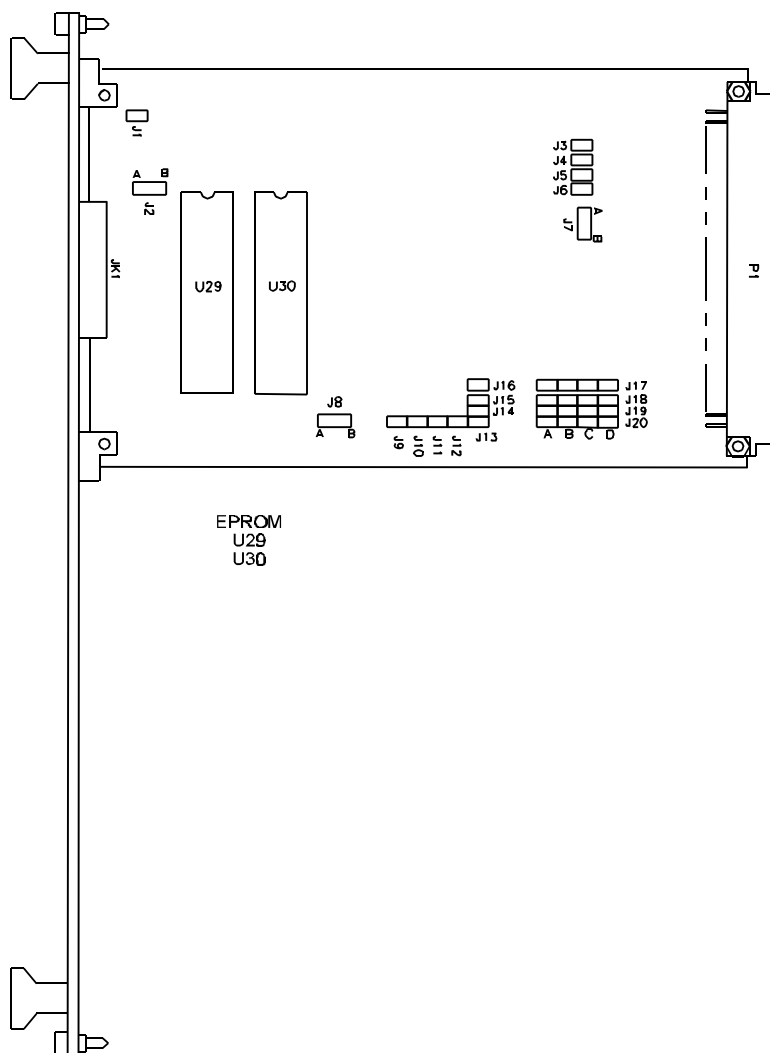
FIGURE 2

DCP CPU EPROM LOCATIONS
(ALL COMPONENTS NOT SHOWN)

10. Using an IC extractor, remove the U29 and U30 EPROMs from the DCP CPU printed circuit boards 2A1A2A1 (and 2A1A2A2 if installed). Place the removed ICs in a conductive foam or on some other static-free surface. (Refer to figure 2 for IC locations.)
11. Remove the new EPROM ICs from the protective package and insert them into the DCP CPU board sockets in accordance with the following chart. Using the IC insertion tool and ensuring that the EPROMs are installed with pin 1 (as identified by notch in top of the IC) oriented toward the board connector, press the EPROMs into their respective sockets.

<u>IC socket</u>	<u>IC part number</u>
U29	62828-45018-1 Version 1.90
U30	62828-45019-1 Version 1.90

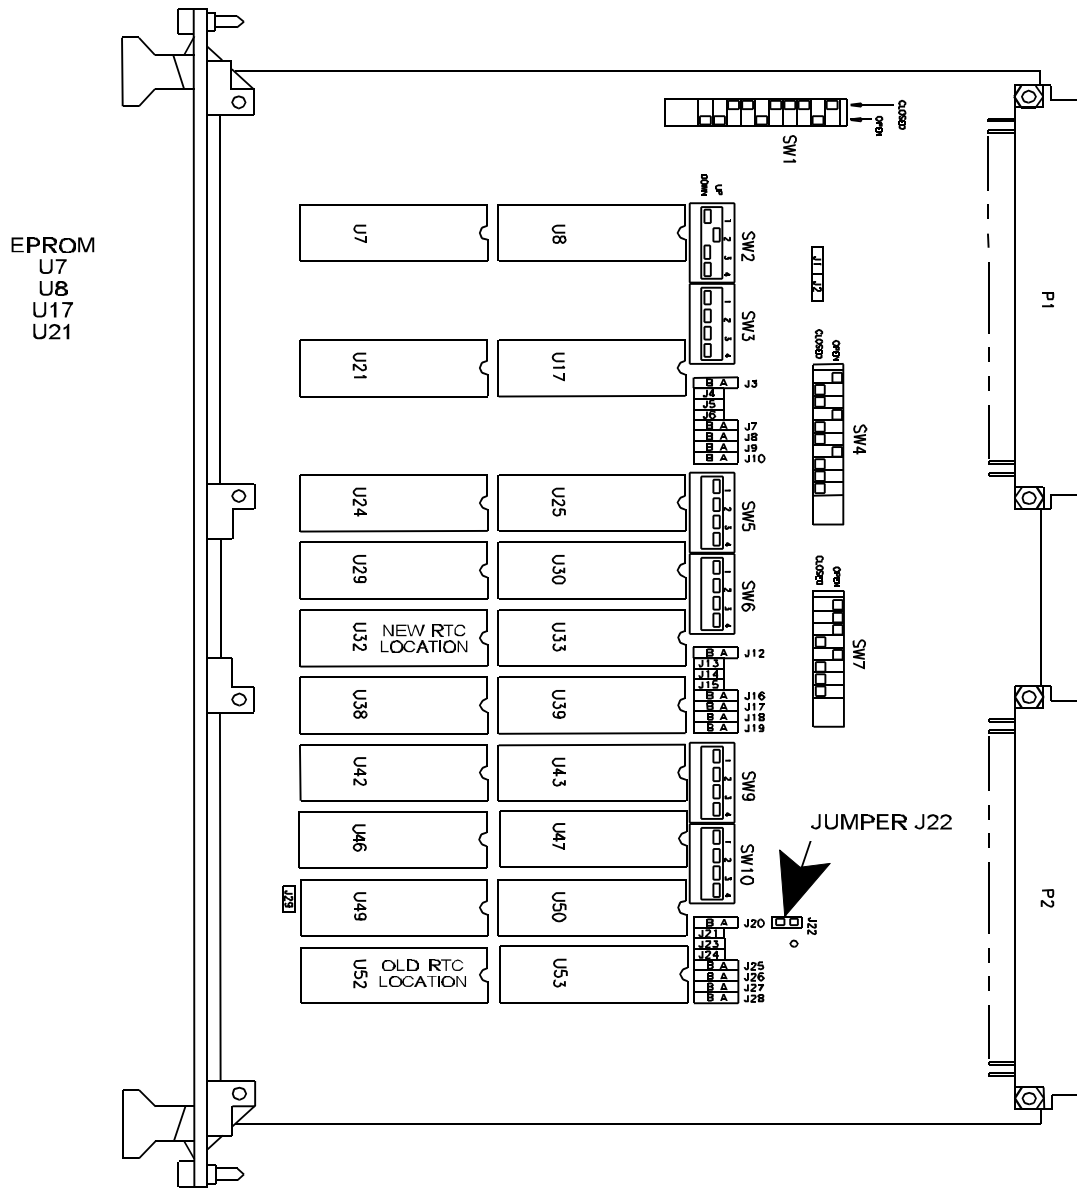
FIGURE 3

ACU MEMORY BOARD EPROM LOCATIONS
(ALL COMPONENTS NOT SHOWN)

5. Disconnect jumper J22. This action will remove the battery power from the memory board and is necessary to 'cold boot' the system. (Refer to figure 3 for jumper location.)

7. Using the IC extraction tool, remove the U7 EPROM from the front of the board slide. Carefully lift up on U7 to remove it from the socket as evenly as possible. After U7 is removed from the socket, place in a conductive foam or on some other static-free surface. (Refer to Figure 3 for IC locations.)
8. Repeat step 7 for the removal of the following ICs: U8, U17 and U21.
9. Remove the new EPROM ICs, for V2.6, from the protective package and insert them into the memory board sockets in accordance with the following chart. Using the IC insertion tool and ensuring that the EPROMs are installed with pin 1 (as identified by notch in top of IC) oriented toward board connectors P1 and P2, as shown on figure 3, press the EPROMs into their respective sockets.

<u>IC socket</u>	<u>IC part number</u>
U8	62828-45002-1
U17	62828-45003-1
U7	62828-45004-1
U21	62828-45005-1
